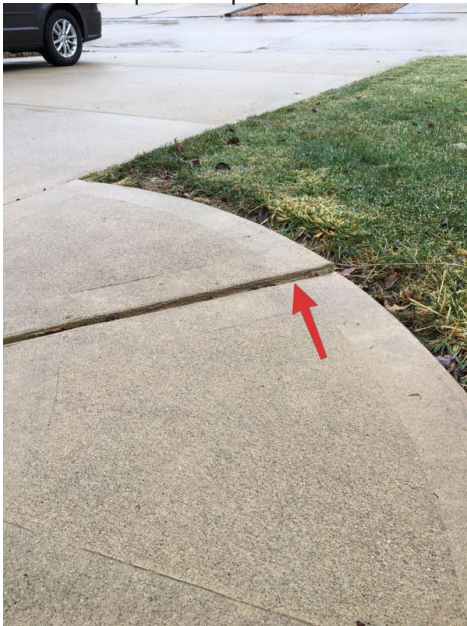
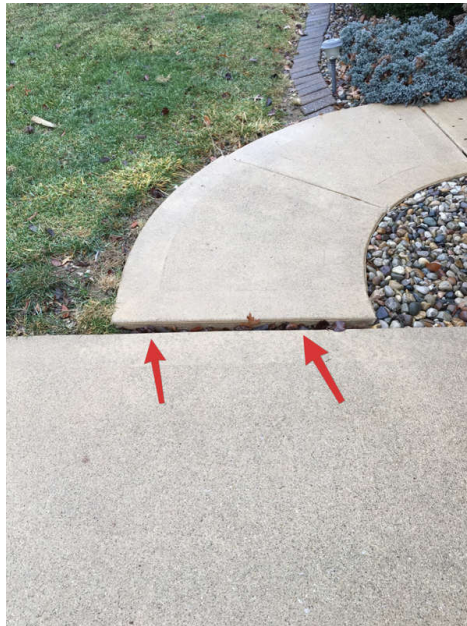
2.1.1 Service Walk(s)

TRIP CONCERN

The service walk had an area that may present a trip concern. For improved safety I recommend having a professional evaluate and correct as needed.

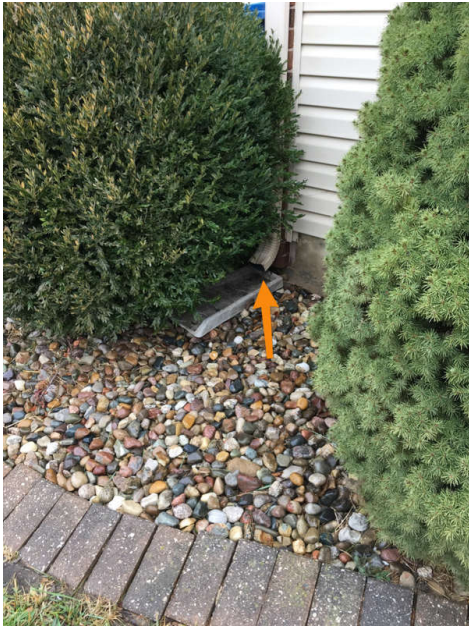
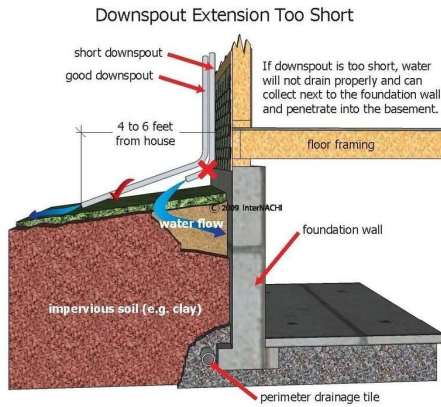
WEST

DOWNSPOUTS TERMINATE NEAR FOUNDATION

As an improvement I recommend adding an extension(s) to the downspout(s) at least 5 feet long so water can be properly discharged away from the foundation.

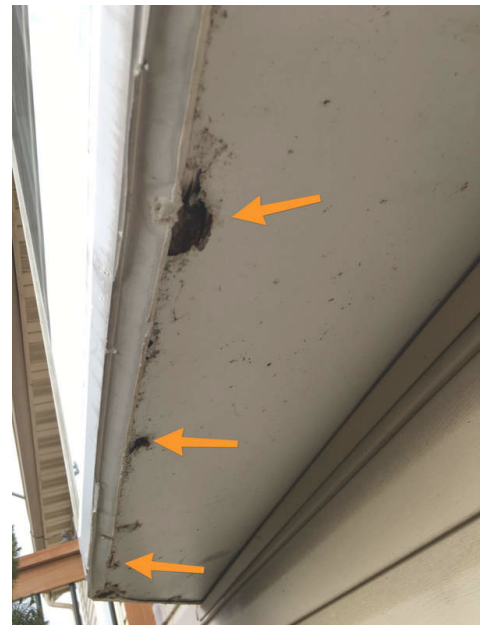
3.2.1 Siding

DETERIORATING

Wood was starting to deteriorate under window. I recommend having a professional evaluate and correct as needed.

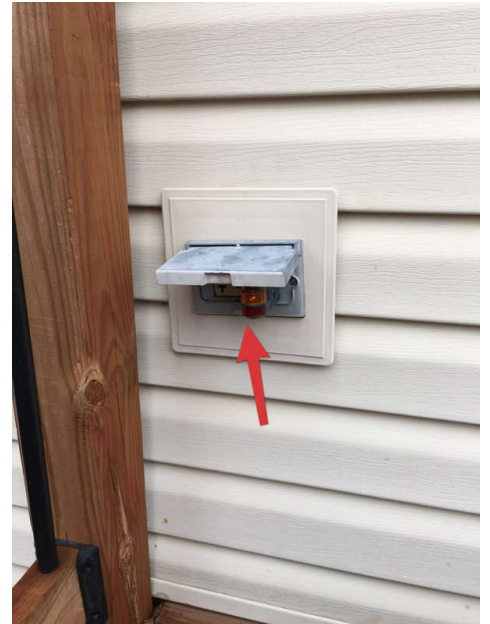
SOUTH

GFCI NOT OPERABLE

The exterior GFCI outlet did not trip when tested. For improved safety I recommend having a professional evaluate and correct as needed.

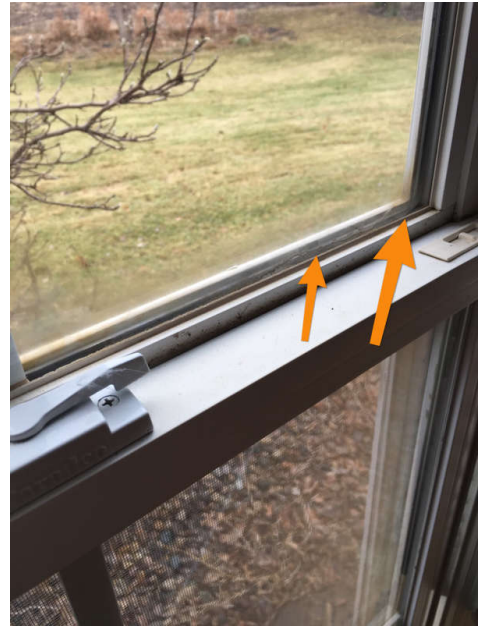
LIVING ROOM

CONDENSATION BETWEEN WINDOW PANES

There was condensation in between the window panes of the window. This is a sign of a leaking glass seal. As an improvement I recommend having a professional evaluate and correct as needed.

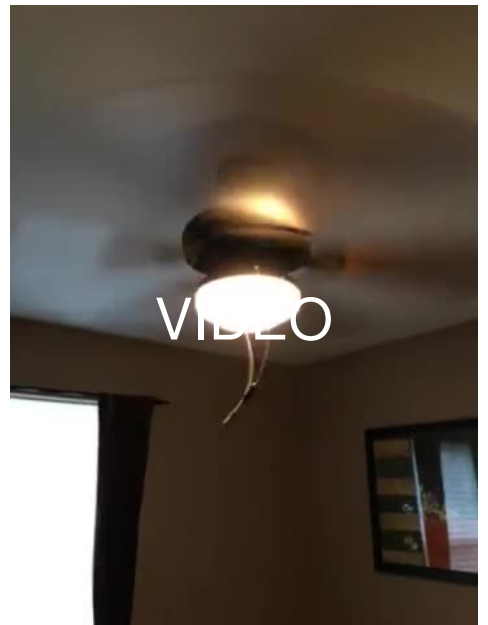
NORTHWEST BEDROOM

CEILING FAN WOBBLY

Ceiling fan was wobbly. As an improvement I recommend having a professional evaluate and correct as needed.

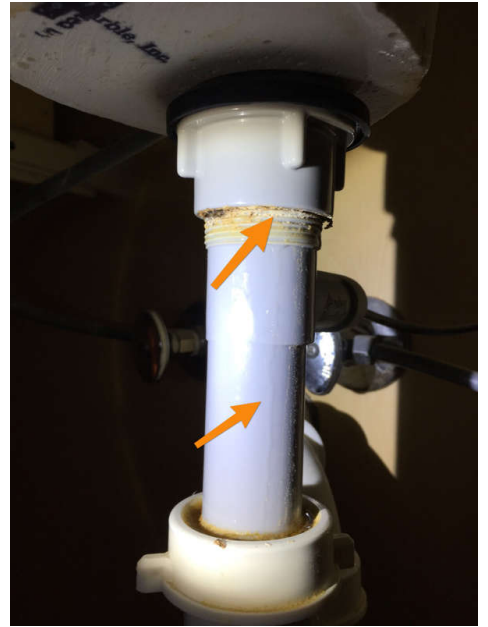
MASTER BATHROOM

SINK LEAK

The bathroom sink had a leak in the drain pipes underneath. As an improvement I recommend having a professional evaluate and correct as needed.

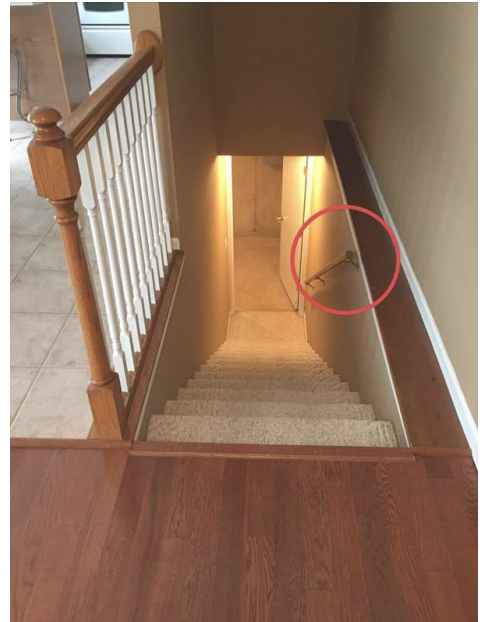
10.1.1 Stairs/Steps

HANDRAIL NOT FULL LENGTH OF STAIRS

The handrail was not the full length of the stairs, it was not within reach on the first 3-4 steps. For improved safety I recommend having a professional evaluate and correct as needed.

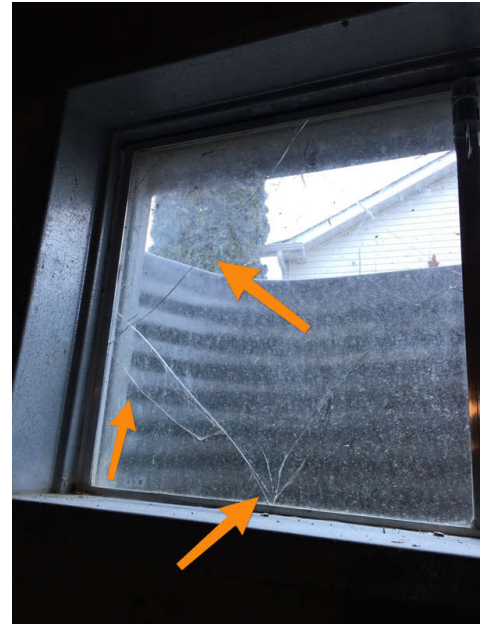
BASEMENT EAST

CRACKED

Window pane had cracks. As an improvement I recommend having a professional evaluate and correct as needed.

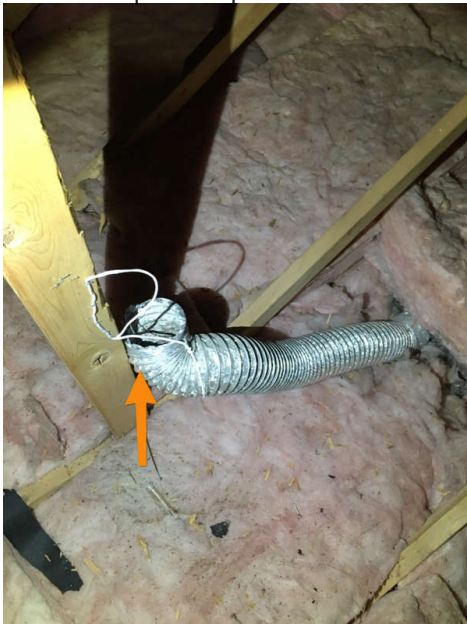
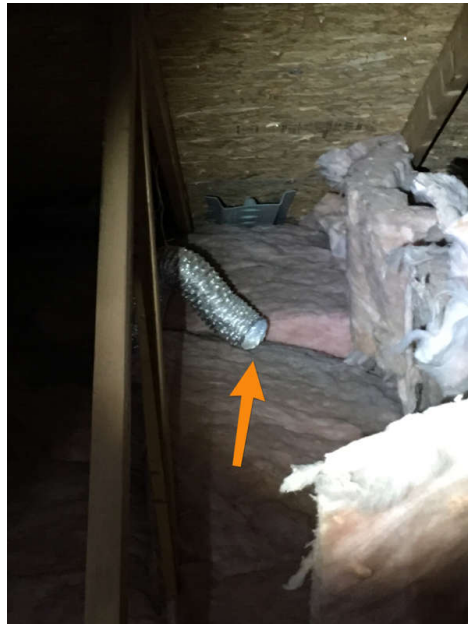
11.1.1 Attic

VENT(S) EXHAUSTING INTO ATTIC

The bathroom exhaust vents were exhausting directly into the attic. This is not recommended as the warm moist air could cause mold/mildew and deteriorate structural members in the attic over time. As an improvement I recommend having the bathroom exhaust(s) routed to a roof, gable or soffit vent so it can be exhausted outside.

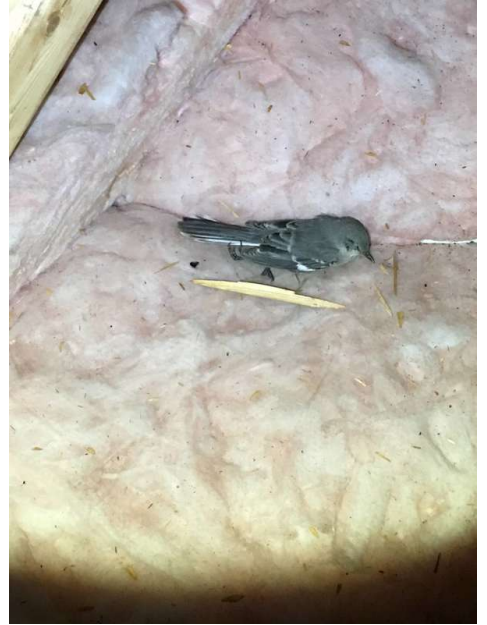
11.1.2 Attic

DEAD BIRD

There was a dead bird in the attic above where the hallway is. I recommend having it removed.

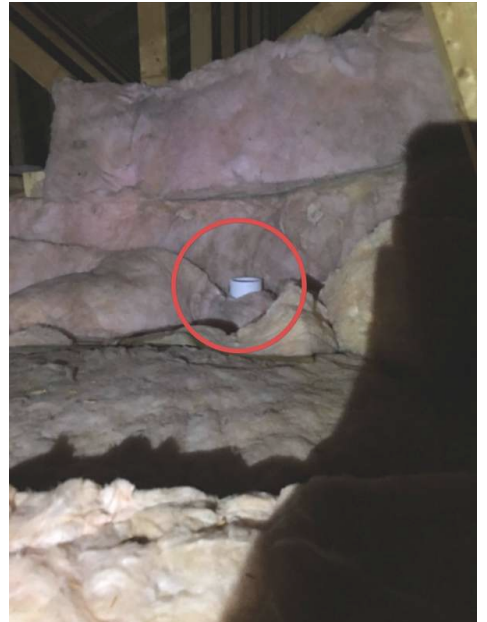
11.1.3 Attic

RADON MITIGATION SYSTEM EXHAUSTING INTO ATTIC

The radon mitigation system appeared to be exhausting into the attic. The exhaust should exhaust through the roof. For improved safety I recommend having a professional evaluate and correct as needed.

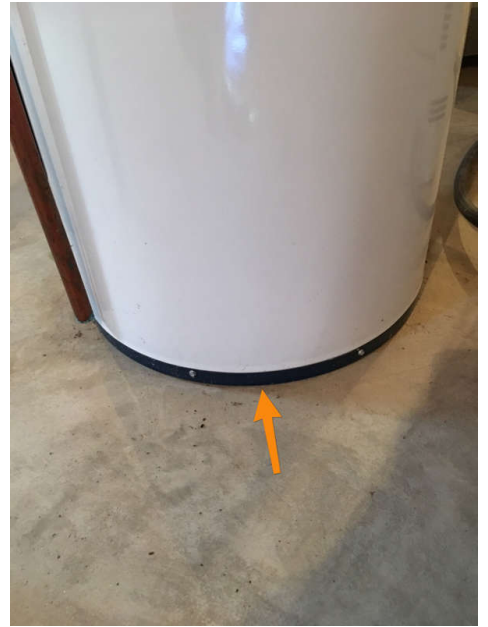
12.3.1 Water Heater

RECOMMEND RAISING WATER HEATER OFF GROUND

As an improvement and to help keep the water heater from rusting prematurely I recommend raising the water heater off the ground a few inches on a support.

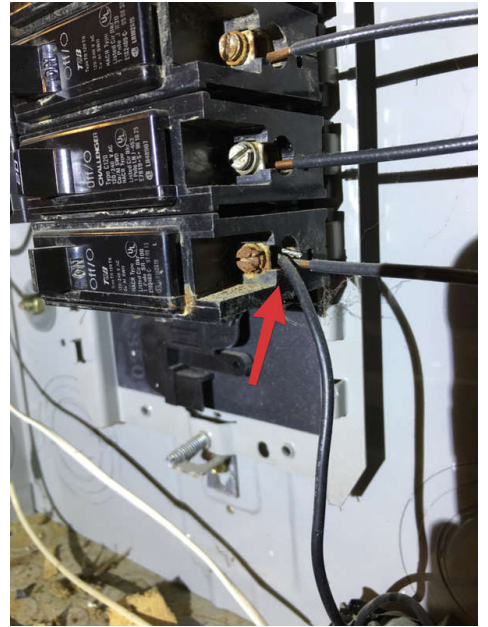
15.1.1 Main Panel

DOUBLE TAP

There was a double tap on a breakers in the electrical panel. This means there are two wires under the same screw on a single breaker. This can cause a loose connection of the wires with the breaker. For improved safety I recommend having a professional evaluate and correct as needed.

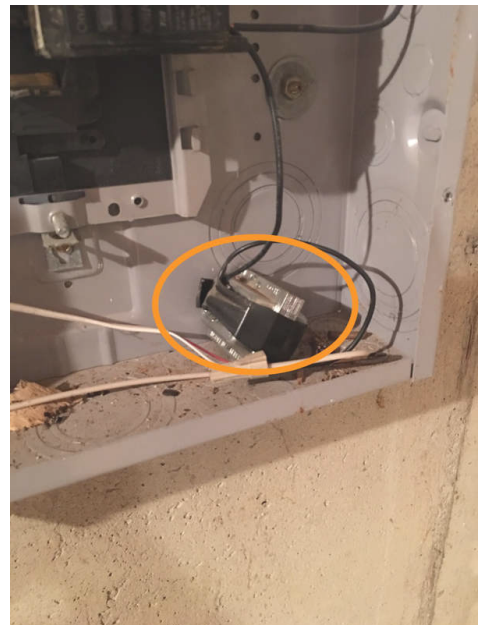
15.1.2 Main Panel

**DOORBELL TRANSFORMER
IN PANEL**

The doorbell transformer was sitting in the electrical panel. This is not recommended as it should be mounted outside of the electrical panel. I recommend having a professional evaluate and correct as needed.

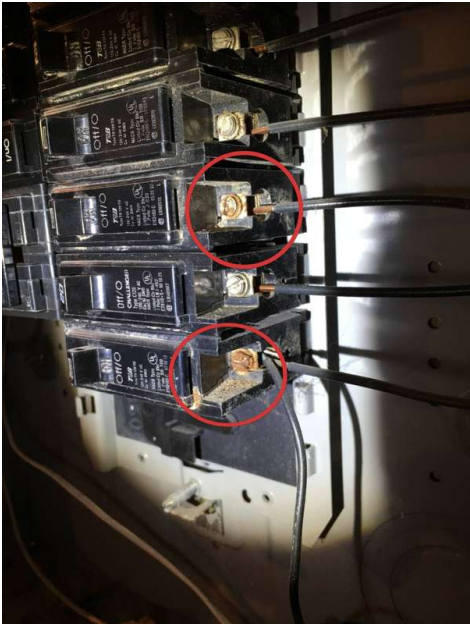
15.1.3 Main Panel

CORROSION ON BREAKERS

There was some corrosion on a couple of breakers in the electrical panel. As an improvement I recommend having a professional evaluate and correct as needed.
