RESIDENTIAL REPORT

1234 Main St.
Cottage Hills Illinois 62018

01/11/2018 9:00AM

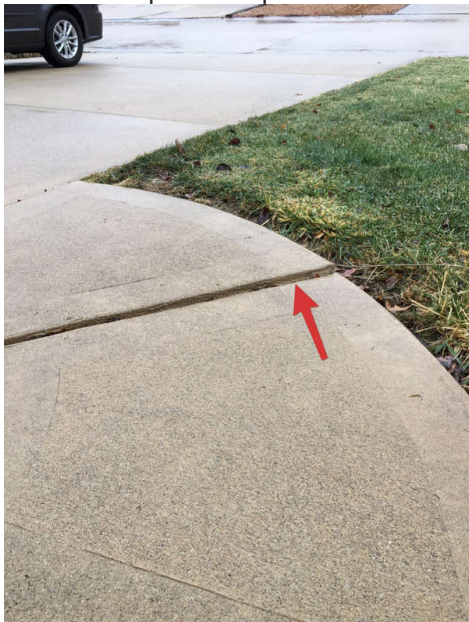
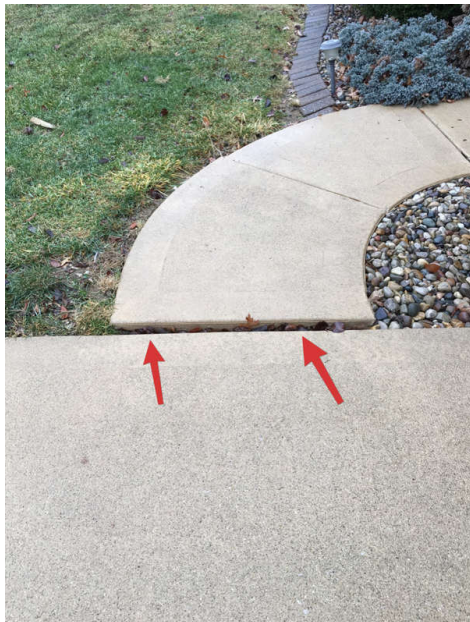
2.1.1 Service Walk(s)

TRIP CONCERN

The service walk had an area that may present a trip concern. For improved safety I recommend having a professional evaluate and correct as needed.

Contact a qualified professional.

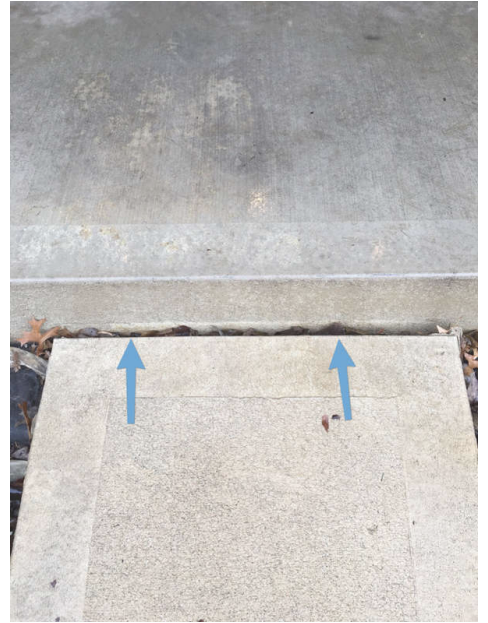
2.1.2 Service Walk(s)

SEAL GAP

As an improvement I recommend sealing the gap in the service walk.

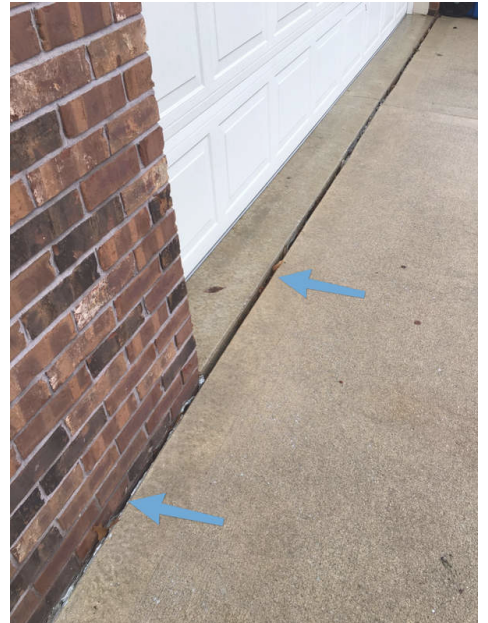
2.2.1 Driveway(s)

SEAL GAPS

As an improvement I recommend sealing gaps in the driveway.

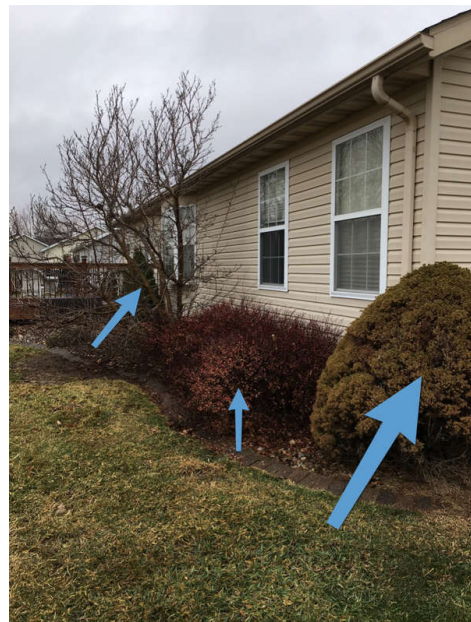
2.5.1 Vegetation, Grading & Drainage

TRIM TREES & VEGETATION

As an improvement I recommend trimming back trees and vegetation away from the home as they may cause damage to the home over time.

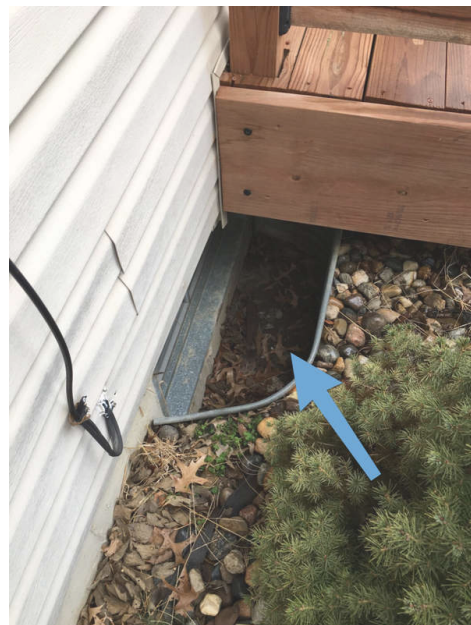
2.5.2 Vegetation, Grading & Drainage

WINDOW WELL COVERS

As an improvement I recommend installing window well covers over the basement windows (As an FYI there were some window well covers in the attic of the house not being used).

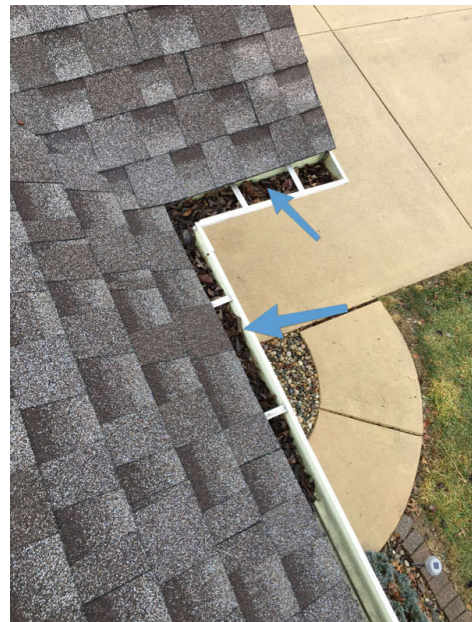
3.1.1 Gutters

DEBRIS

As an improvement I recommend cleaning the gutters of debris.

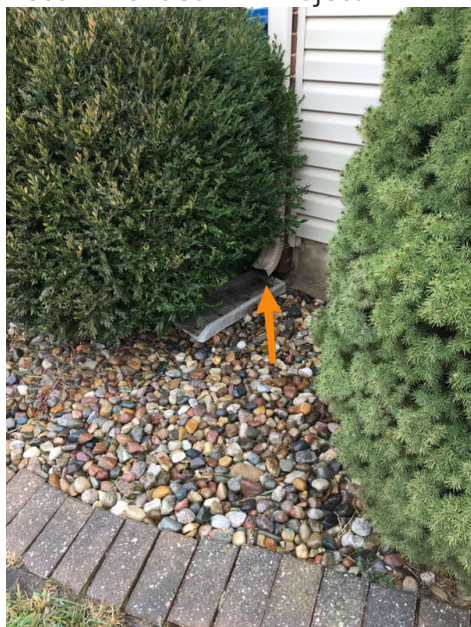
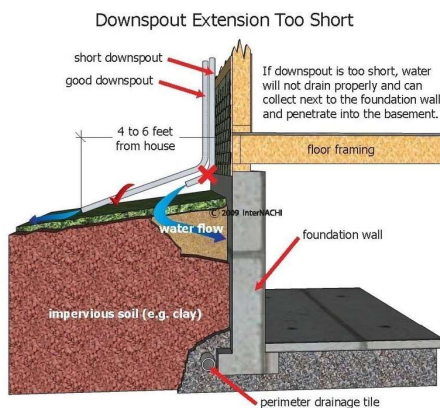
3.1.2 Gutters

DOWNSPOUTS TERMINATE NEAR FOUNDATION

As an improvement I recommend adding an extension(s) to the downspout(s) at least 5 feet long so water can be properly discharged away from the foundation.

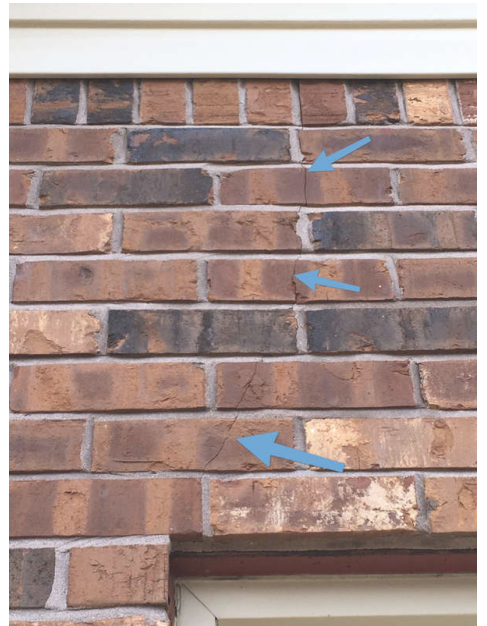
3.2.2 Siding

TYPICAL CRACKING

Brick veneer had typical cracking. As an improvement I recommend having a professional evaluate and correct as needed.

Contact a qualified professional.

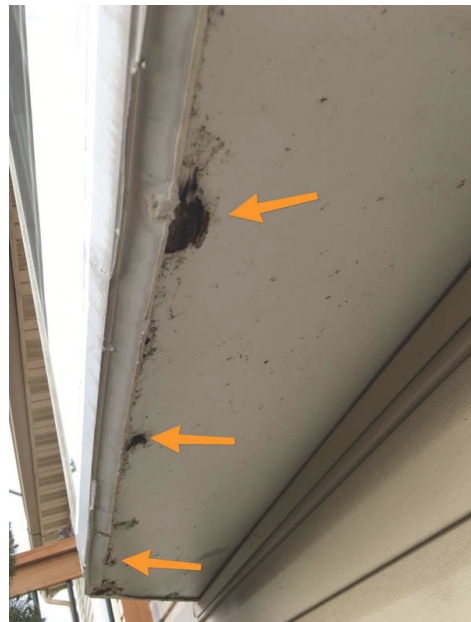
3.2.3 Siding

DETERIORATING

Wood was starting to deteriorate under window. I recommend having a professional evaluate and correct as needed.

Contact a qualified professional.

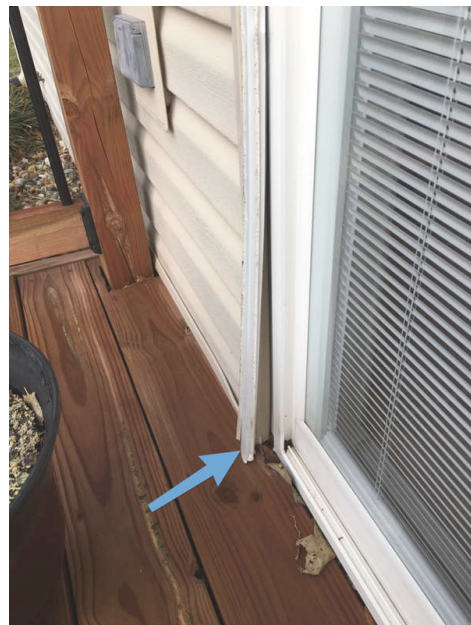
3.3.1 Trim

DETACHED

Trim was detached. As an improvement I recommend having a professional evaluate and correct as needed.

Contact a qualified professional.

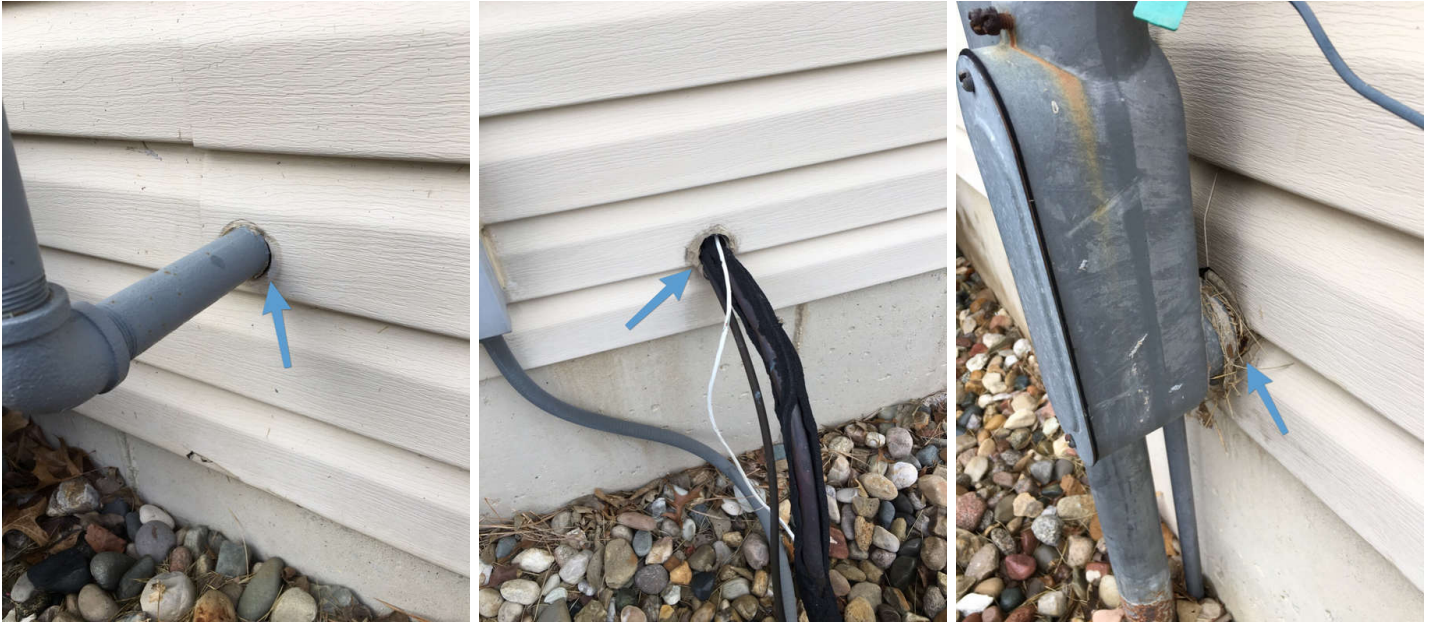
3.7.1 Caulking

PENETRATIONS

As an improved an improvement I recommend caulking around exterior penetrations where needed to prevent bug/moisture/air intrusion.

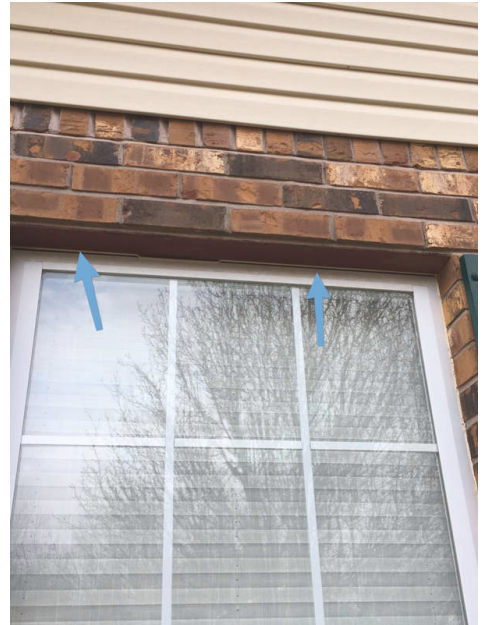
3.7.2 Caulking

WINDOWS

As an improvement I recommend caulking around exterior windows on the home where needed.

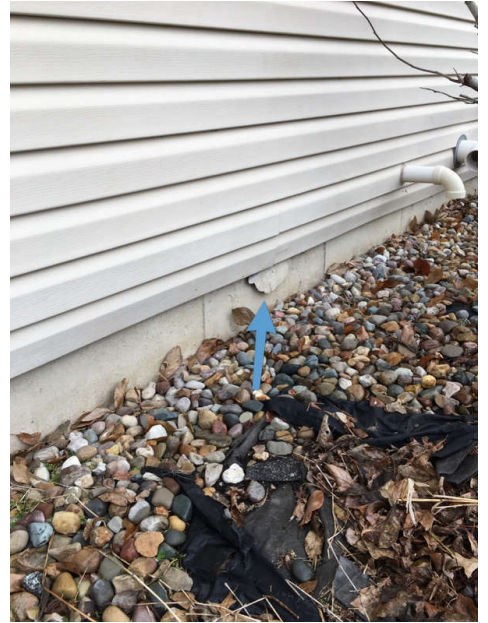
3.9.1 Foundation

CHIPPED

An area of the foundation had a chipped piece. As an improvement I recommend having a professional evaluate and correct as needed.

Contact a qualified professional.

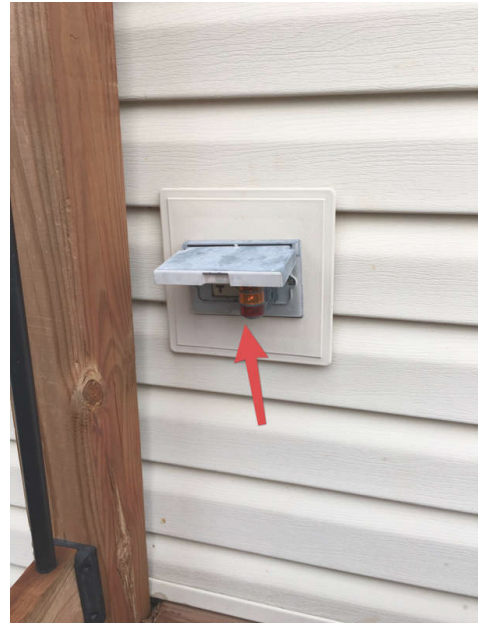
3.10.1 Exterior Electrical

GFCI NOT OPERABLE

The exterior GFCI outlet did not trip when tested. For improved safety I recommend having a professional evaluate and correct as needed.

Contact a qualified professional.

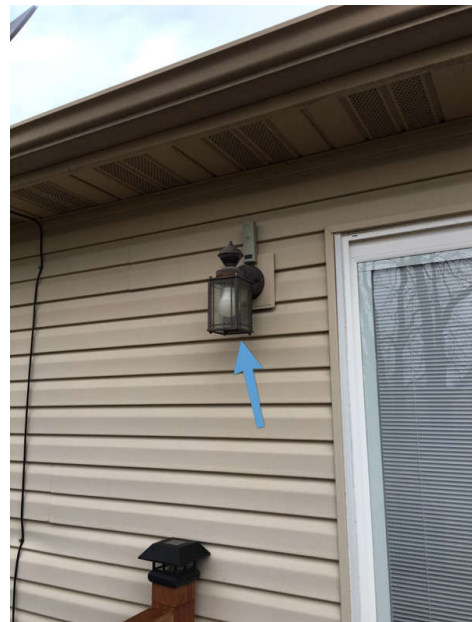
3.10.2 Exterior Electrical

LIGHT OUT

There was a light out on the exterior of the house. As an improvement I recommend changing the bulb.

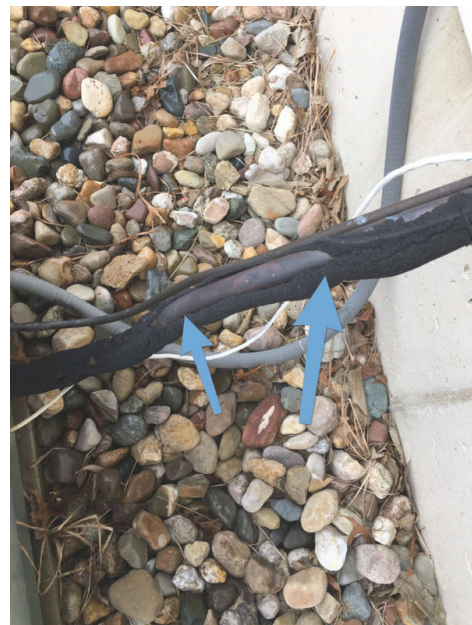
3.12.1 Exterior A/C

INSULATION MISSING OR WORN

Insulation on the exterior A/C refrigerant line was missing or worn. This can cause energy loss and condensation. As an improvement I recommend replacing.

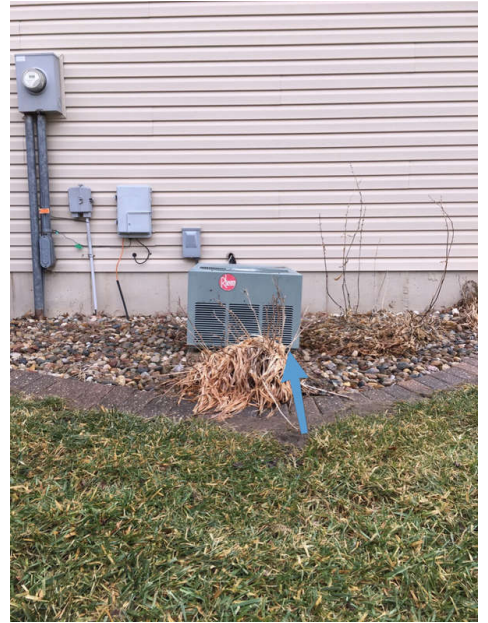
3.12.2 Exterior A/C

UNIT NOT LEVEL

The outdoor A/C condensing unit was not level. This can cause accelerated deterioration of components. As an improvement I recommend having a professional evaluate and correct as needed.

Contact a qualified professional.

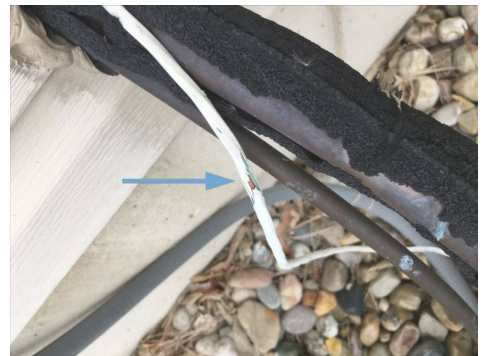
3.12.4 Exterior A/C

WIRE SHEATHING TORN

Wire sheathing was torn on exterior A/C unit wiring. As an improvement I recommend wrapping some electrical tape around it.

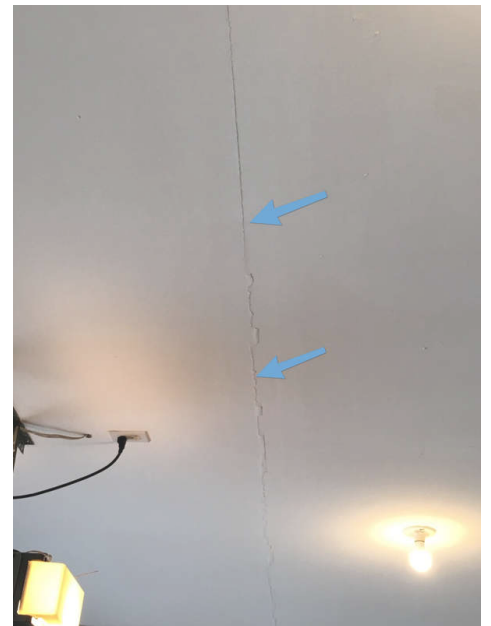
5.7.1 Walls/Ceiling/Door

TYPICAL DRYWALL CRACKS

There were some typical drywall cracks in the garage walls/ceiling. As an improvement I recommend patching.

Contact a qualified professional.

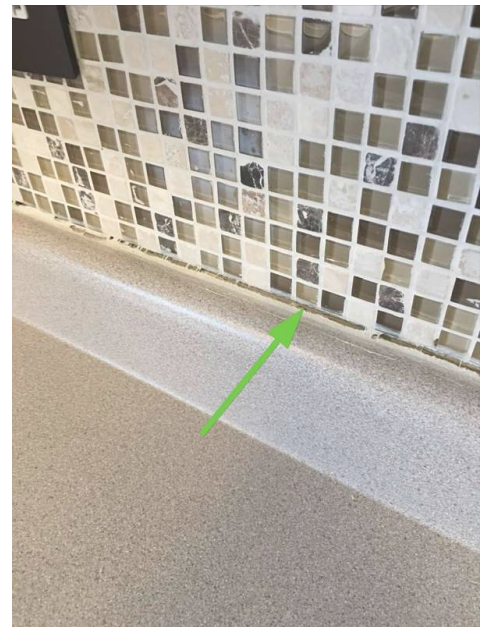
7.1.1 Kitchen

RECOMMEND CAULKING COUNTER TOP

As an improvement I recommend caulking around the kitchen counter top.

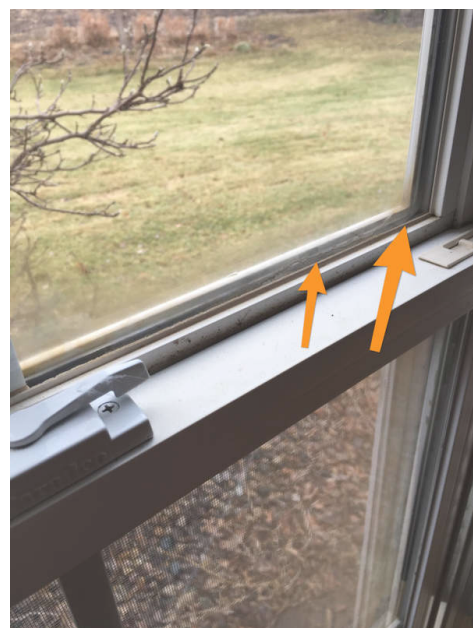
There was condensation in between the window panes of the window. This is a sign of a leaking glass seal. As an improvement I recommend having a professional evaluate and correct as needed.

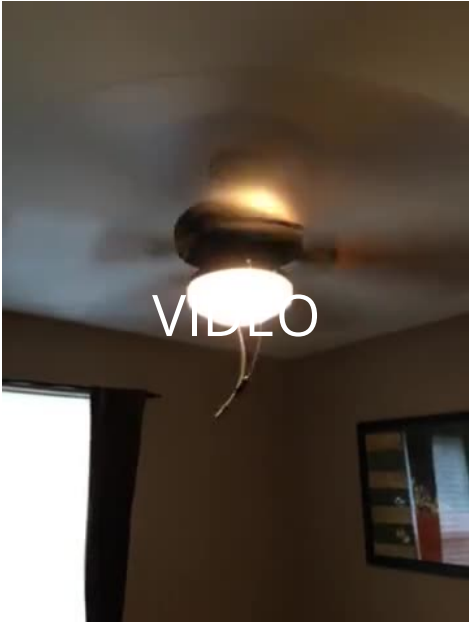
8.1.3 Rooms

CEILING FAN WOBBLY

Ceiling fan was wobbly. As an improvement I recommend having a professional evaluate and correct as needed.

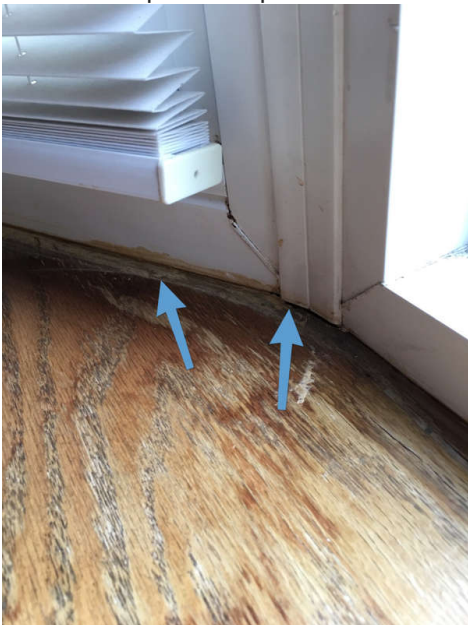
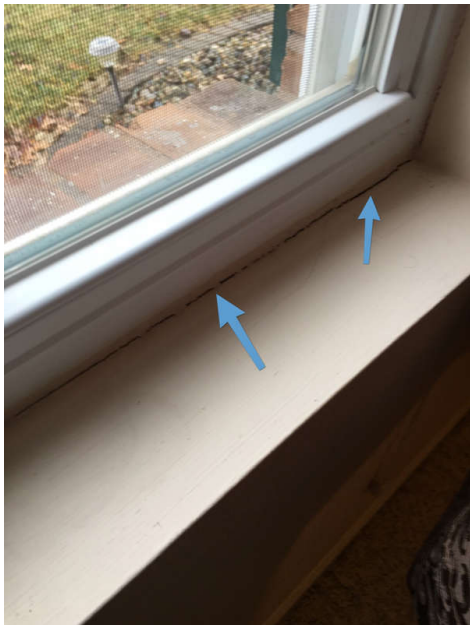
8.1.4 Rooms

CAULK WINDOW(S)

As an improvement I recommend caulking around the window(s).

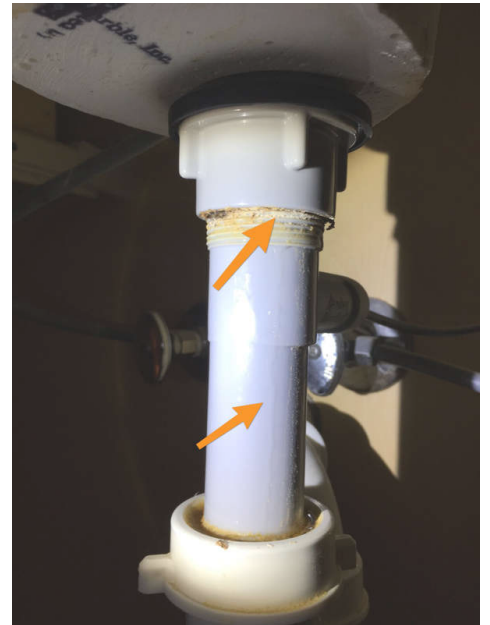
SINK LEAK

The bathroom sink had a leak in the drain pipes underneath. As an improvement I recommend having a professional evaluate and correct as needed.

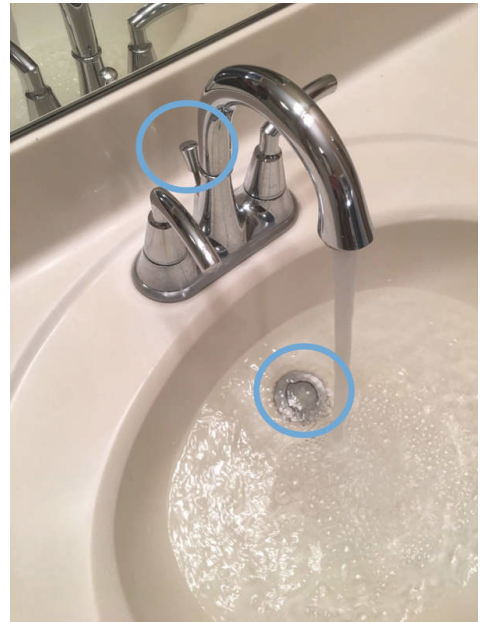
The sink drain stopper does not engage properly. As an improvement I recommend having a professional evaluate and correct as needed.

Contact a qualified professional.

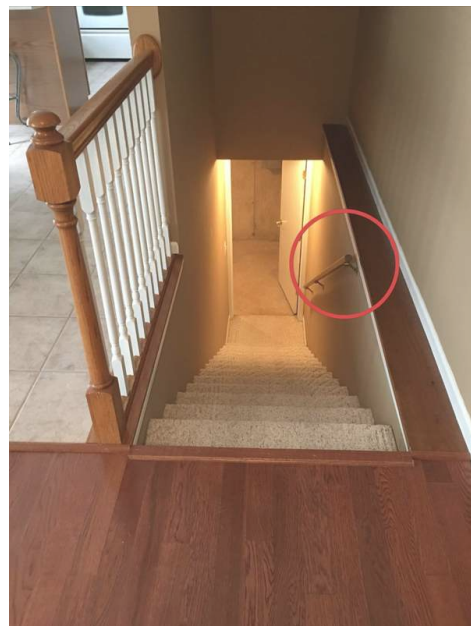
The handrail was not the full length of the stairs, it was not within reach on the first 3-4 steps. For improved safety I recommend having a professional evaluate and correct as needed.

Contact a qualified professional.

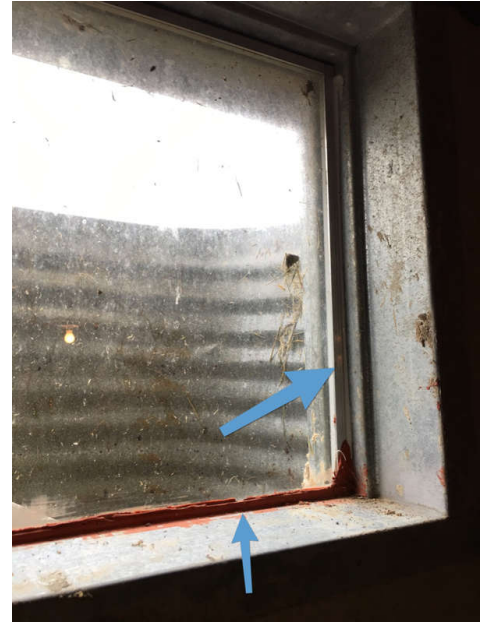
10.2.1 Windows/Screens

CAULKED SHUT

Window was caulked shut. As an improvement I recommend having a professional evaluate and correct as needed.

Contact a qualified professional.

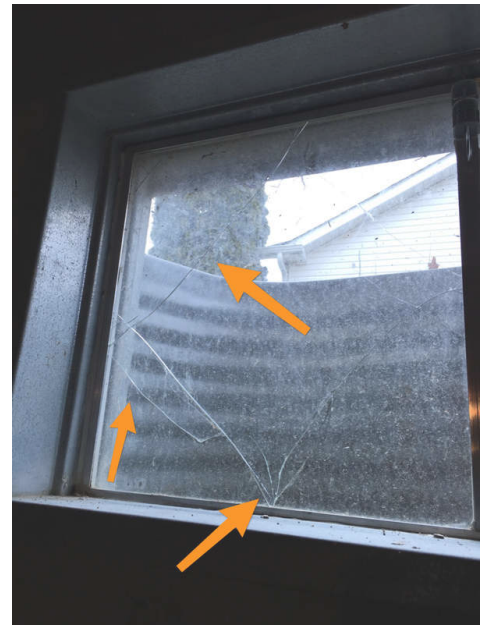
10.2.2 Windows/Screens

CRACKED

Window pane had cracks. As an improvement I recommend having a professional evaluate and correct as needed.

Contact a qualified professional.

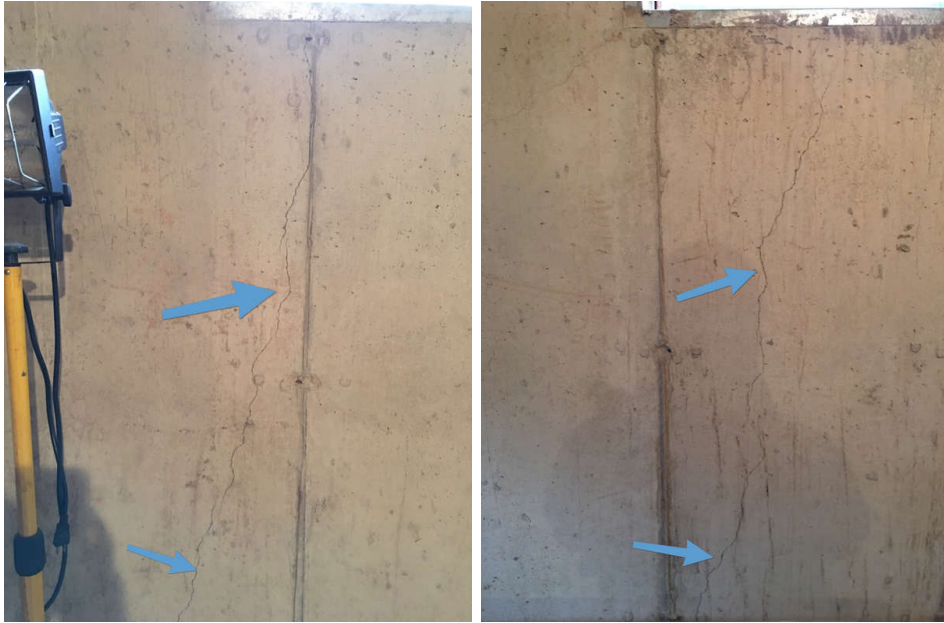
10.3.1 Foundation

TYPICAL CRACKS

Foundation wall had typical cracks. As an improvement I recommend having a professional evaluate and patch/seal.

Contact a qualified professional.

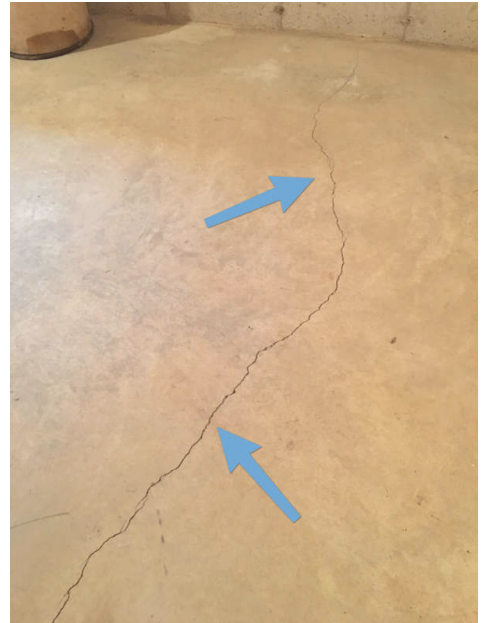
10.4.1 Floor

TYPICAL CRACKS

The basement floor had typical cracks. As an improvement I recommend having a professional evaluate and seal as needed.

Contact a qualified professional.

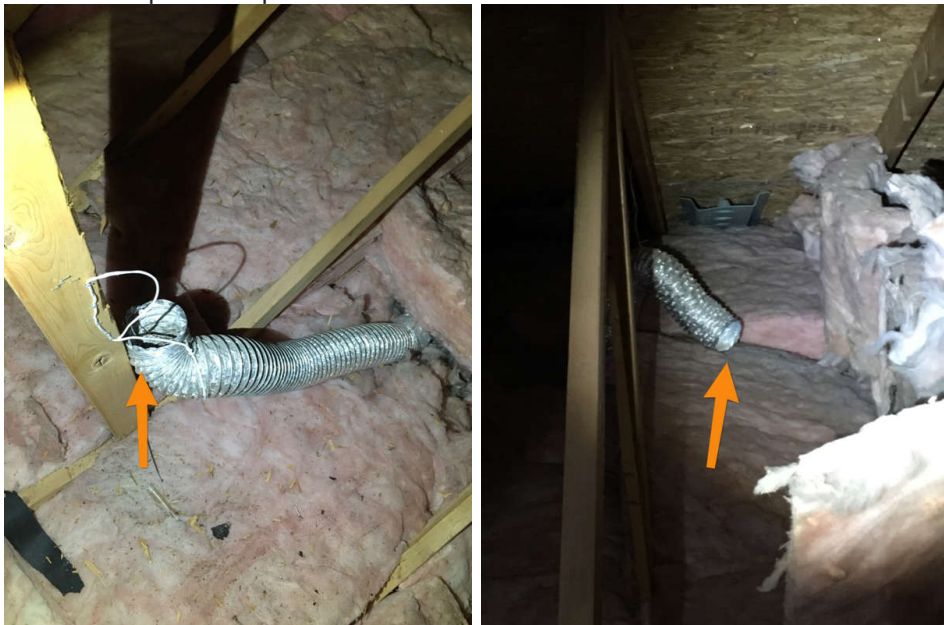
The bathroom exhaust vents were exhausting directly into the attic. This is not recommended as the warm moist air could cause mold/mildew and deteriorate structural members in the attic over time. As an improvement I recommend having the bathroom exhaust(s) routed to a roof, gable or soffit vent so it can be exhausted outside.

Contact a qualified professional.

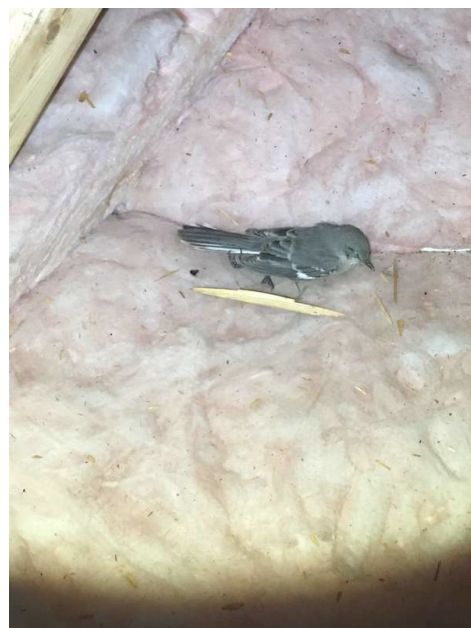
11.1.3 Attic

DEAD BIRD

There was a dead bird in the attic above where the hallway is. I recommend having it removed.

Contact a qualified professional.

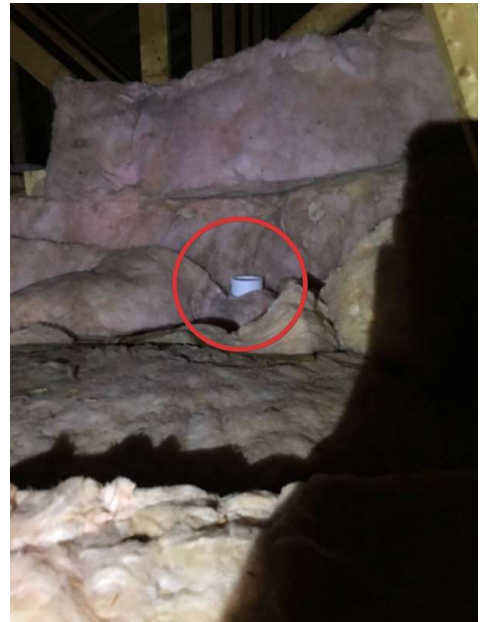
11.1.4 Attic

RADON MITIGATION SYSTEM EXHAUSTING INTO ATTIC

The radon mitigation system appeared to be exhausting into the attic. The exhaust should exhaust through the roof. For improved safety I recommend having a professional evaluate and correct as needed.

Contact a qualified professional.

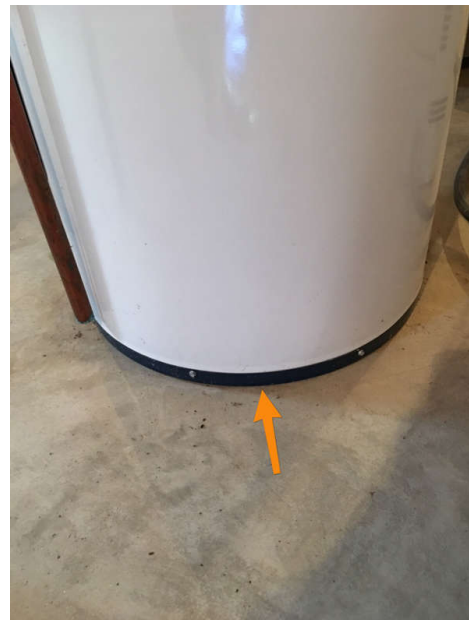
RECOMMEND RAISING WATER HEATER OFF GROUND

As an improvement and to help keep the water heater from rusting prematurely I recommend raising the water heater off the ground a few inches on a support.

Contact a qualified professional.

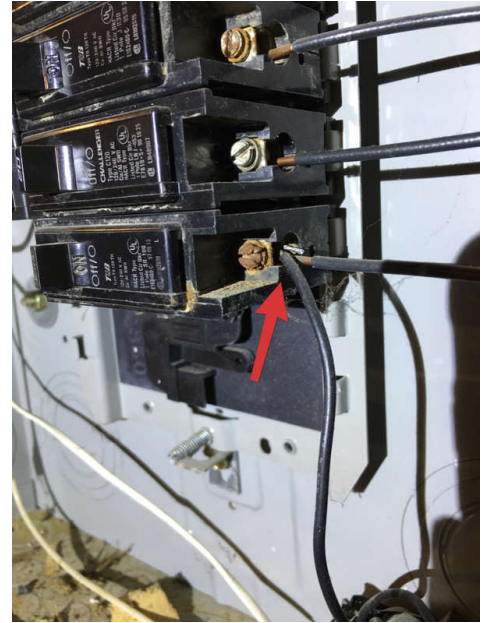
There was a double tap on a breakers in the electrical panel. This means there are two wires under the same screw on a single breaker. This can cause a loose connection of the wires with the breaker. For improved safety I recommend having a professional evaluate and correct as needed.

Contact a qualified professional.

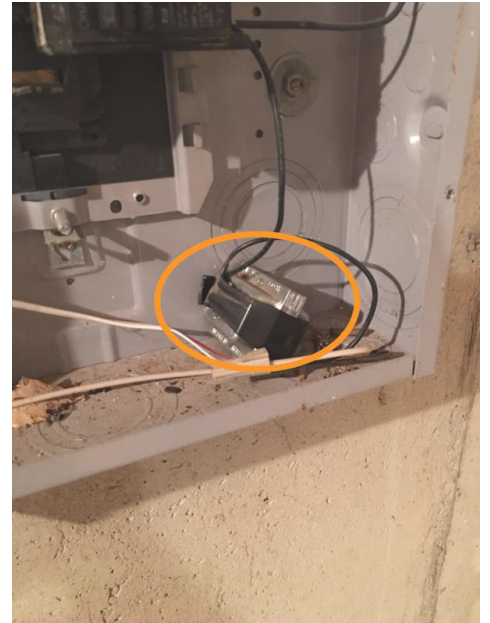
15.1.2 Main Panel

The doorbell transformer was sitting in the electrical panel. This is not recommended as it should be mounted outside of the electrical panel. I recommend having a professional evaluate and correct as needed.

Contact a qualified professional.

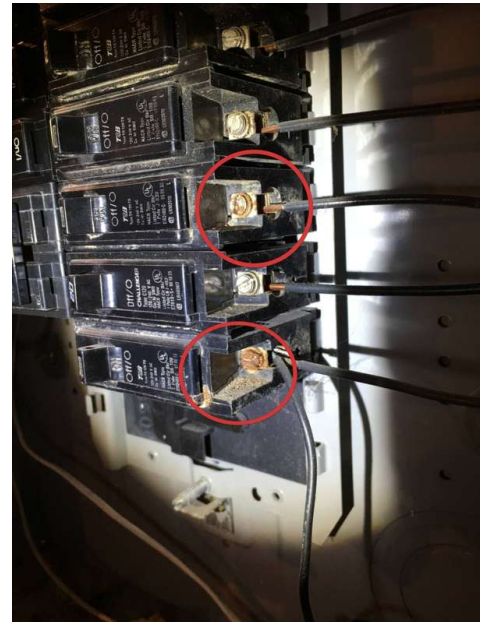
15.1.3 Main Panel

CORROSION ON BREAKERS

There was some corrosion on a couple of breakers in the electrical panel. As an improvement I recommend having a professional evaluate and correct as needed.

Contact a qualified professional.
